Geologic and Geomorphic Aspects of Streambank Erosion in the Yazoo Hill Streams

Robert E. Rentschler
Potamology Section
Hydraulics Branch
Vicksburg District
U.S. Army Corps of Engineers

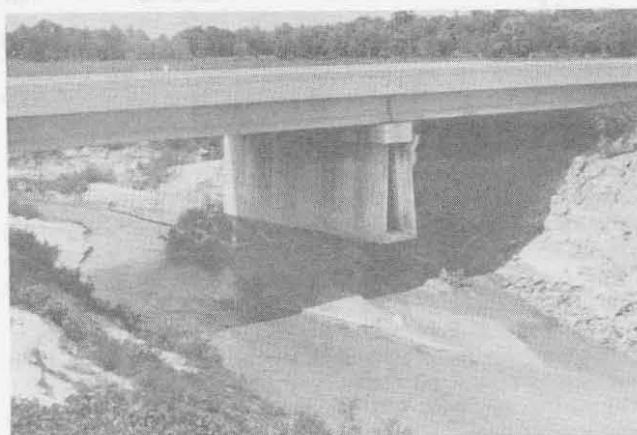
The problem with which this report deals is that the erosion rate in the hill areas of the Yazoo Basin has increased to the extent that economic losses are occurring at an ever increasing rate within the Basin. These losses come not only from the loss of agricultural land, but from the destruction of roads, buildings, bridges, and various other natural and man-made features. (Fig 1 & 2).

Fig. 1. Degradation at Bridge Site - 1 Year After Completion

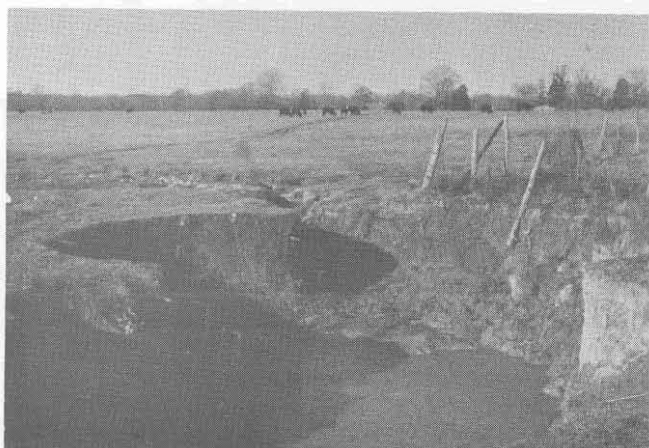
Fig. 2. Headcut Moving Through Pasture

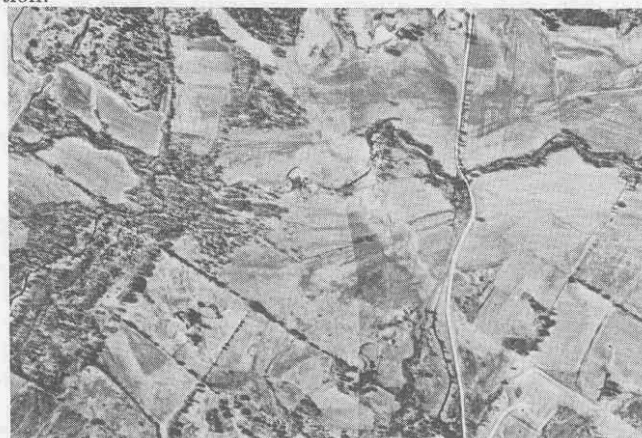
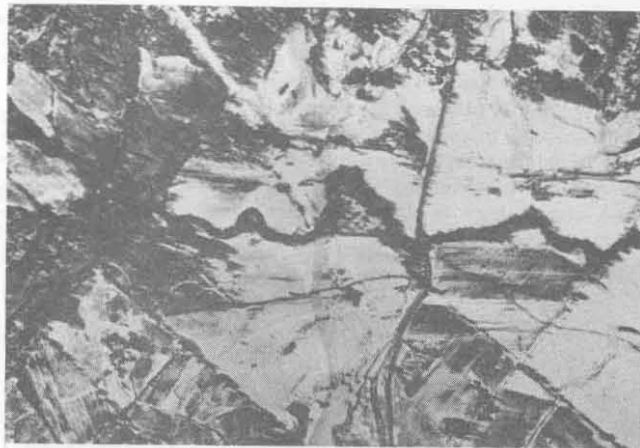
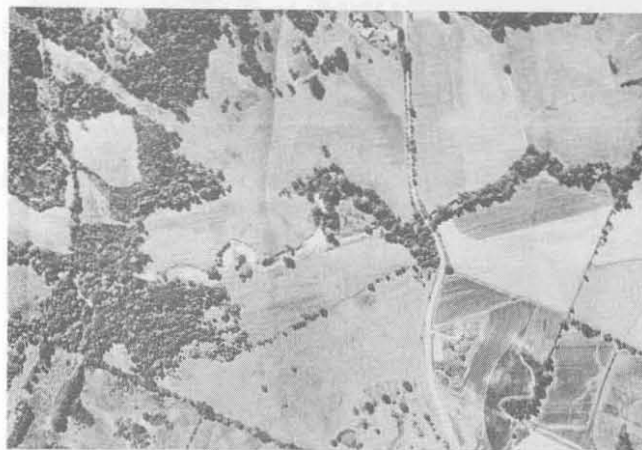
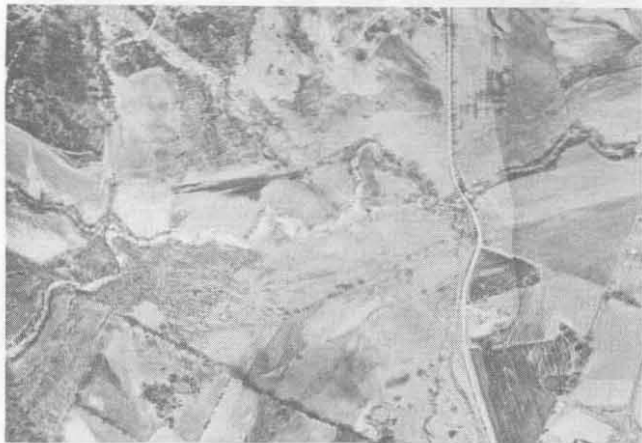
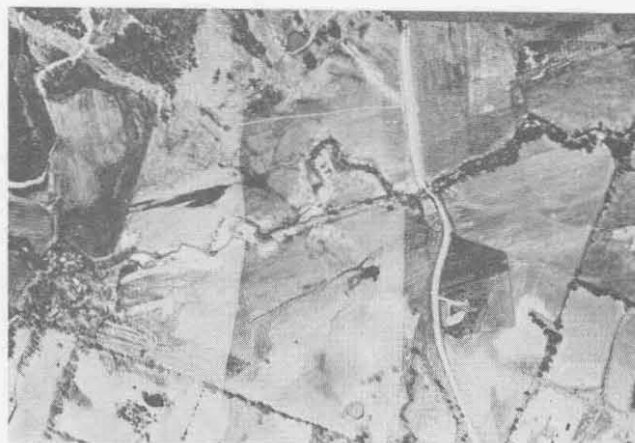
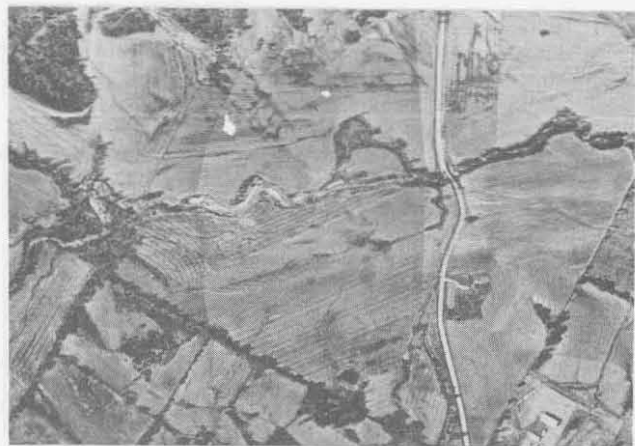
increase water surface and thalweg slopes, decrease stream sinuosity, and encourage degradation upstream and aggradation downstream of the work. Figure 3 is a schematic of the before and after conditions of a cutoff. Channel straightening can be considered as an elongated cutoff, and therefore, its effect upon a stream may have a more pronounced effect than a single cut-off. Figures 4-9 are examples of what one short cut-off has done to the upper reaches of South Fork Tillatoba Creek.

From this series of aerial photos, it is apparent that the instability of the reach above the cut-off was instigated by the "channel improvement" works downstream. Before the cut-off, the entire reach was stable and tree lined. The construction of the cut-off upset the stream's natural slope, alternate bar sequence, sediment movement, and channel geometry. The combination of those factors destroyed any natural grade or bed control which was present and a headcut or lowering of the stream's base level was started.

Fig. 4. Cutoff on South Fork Tillatoba 4 Feb 69

Fig. 5. Cutoff on South Fork Tillatoba 9 Feb 71

Fig. 6. Cutoff on South Fork Tillatoba 30 Sep 74

Fig. 7. Cutoff on South Fork Tillatoba 18 Mar 76

Fig. 8. Cutoff on South Fork Tillatoba 23 Mar 77

Fig. 9. Cutoff on South Fork Tillatoba 12 Mar 79

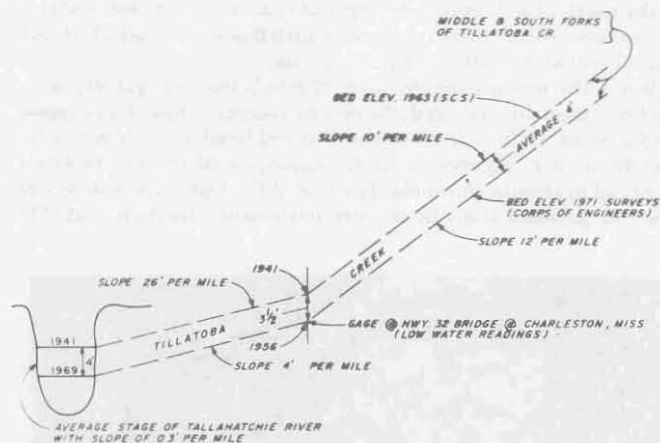
Eventually the stream will regain its natural slope, but in the process, many acres of farmland will be rendered useless or completely destroyed by caving banks. This process will involve the upstream migration of the head-cut until the thalweg slope between the sources of the stream and the cut-off are approximately the same as before the cut-off or until the headcut encounters some geologic or man-made control which will stop the bed degradation. Figure 10 is a schematic of how the bed of Tillatoba Creek has degraded.

From this diagram it is evident that the base level of Tillatoba Creek, namely the Tallahatchie River, was lowered by approximately 4 feet. This instigated a series of headcuts which proceeded up Tillatoba Creek and lowered this creek by the same amount. It should also be kept in mind that this is only one example and that each tributary has undergone similar degradation.

Fig. 10. Comparative Thalweg Surveys, Tillatoba Creek

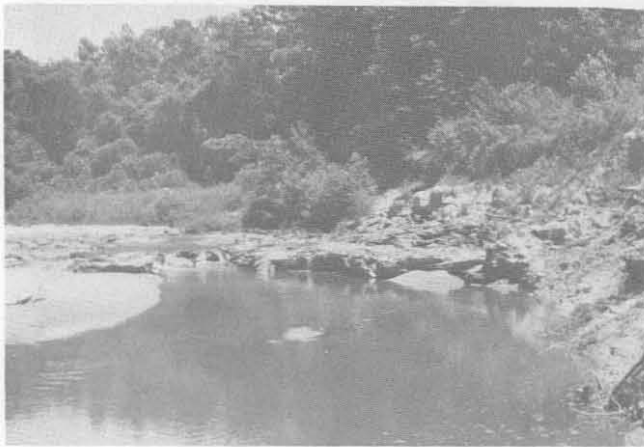
As previously mentioned, the streams with which we are dealing, primarily the hill streams north of Yazoo City, have definite lack of stabilizing geologic formations within the channels themselves. Any bed rock that is exposed within the channels is predominately a poorly cemented iron sandstone generally referred to as "ironstone." (Figure 11) The ironstone is

actually the uppermost layers of the Zilpha Formation of Eocene Age which were cemented after deposition by solution activity. Even though these layers do afford a more resistant geologic bed control, the cementation breaks down eventually, and the headcut will proceed further upstream. These ironstone ledges can only be considered a temporary natural grade control. Any work that is contemplated on a stream which has these formations must consider these as such and take precautions to preserve the natural slope of the stream and not accelerate the

Fig. 11 "Ironstone" Exposed in Channel

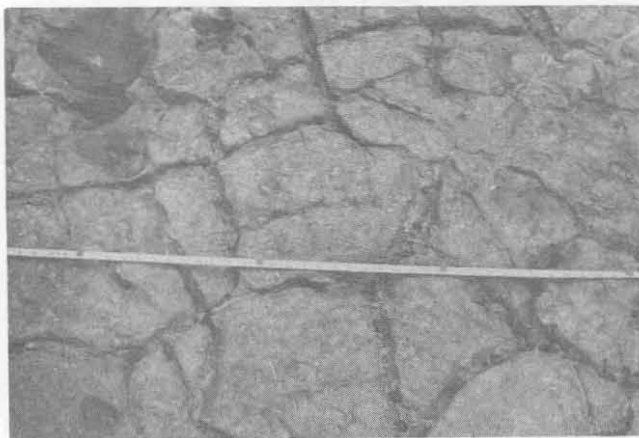
On top of the pre-settlement alluvium are two layers of paleosols or buried soils. These two paleosols have been radio-carbon dated at approximately 10,000 and 5,000 years old. The old paleosol is characteristically a brown to buff colored silt with a very pronounced polygonal structure. (Figure 12) This structure is the result of a thorough drying and cracking of the soil and the subsequent filling in of the cracks with a fine sand or silt. The soil was then buried with younger deposits.

Fig. 12. Polygonal Cracks on "Old" Paleosol

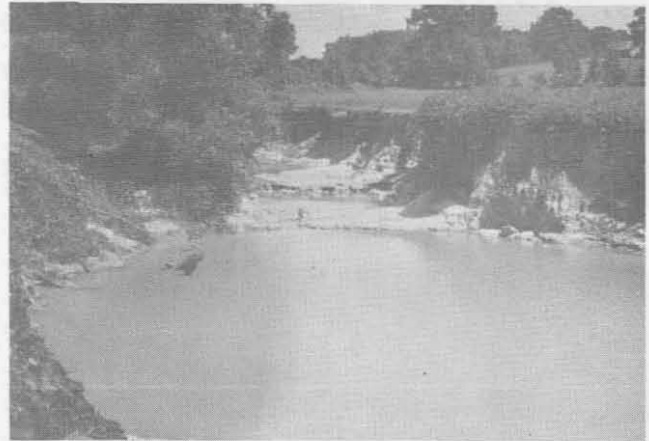
When the streams erode down through the younger deposits and reexpose this paleosol, the cracks become zones of weakness and a block failure or a type of vertical headcuts 2 to 6 feet in height occurs. Figures 13-15 are examples of the old paleosol exposed in stream channels. The rate of the headcuts is slower in the old paleosol than in the pre-settlement alluvium, but this

Fig. 13. "Old" Paleosol Exposed in Channel

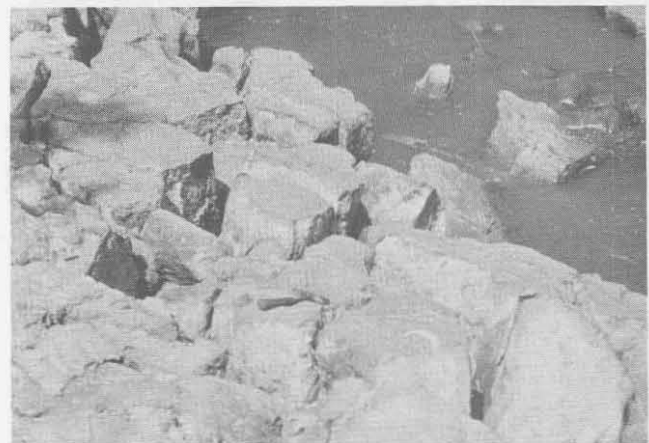
Fig. 14. Close-up of Old Paleosol Block Failure

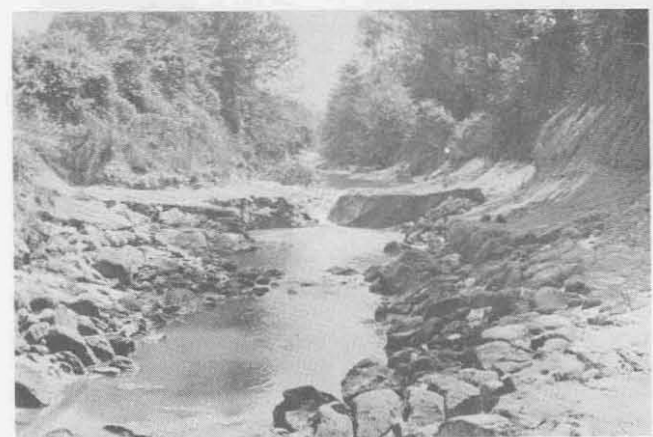
Fig. 15. Hotophia Creek Headcut

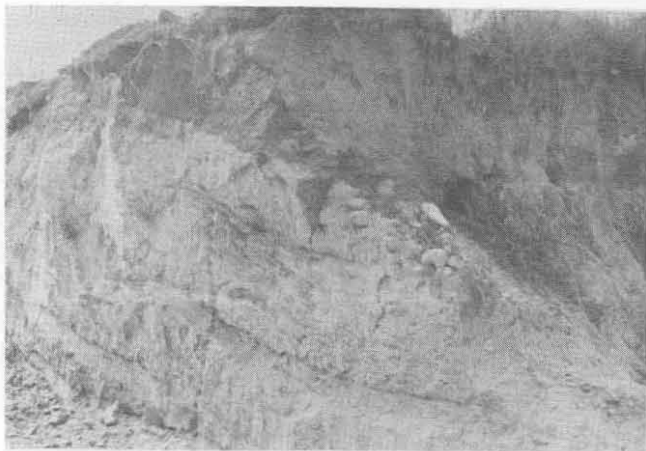
The younger paleosol (Figure 16) is essentially a channel fill deposit in the old paleosol. It is a poorly layered light gray silt with fine sand inter-layered. This structure offers very little erosion resistance. Due to the nature of the deposition of this unit, the aerial extent of young paleosol's influence upon present day stream morphology is limited to the intersection of present

Fig. 16. Young Paleosol in Bank

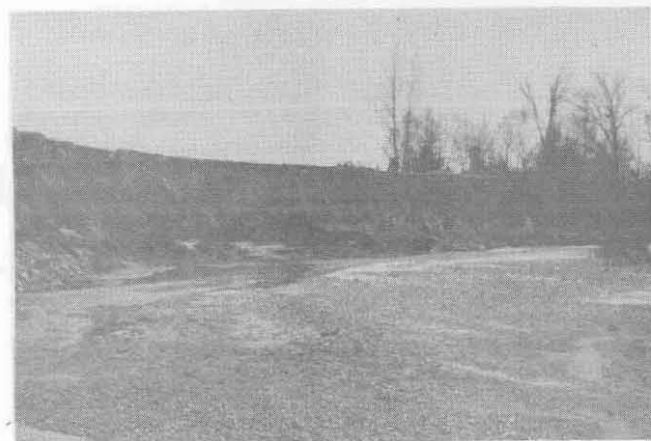
Capping the entire sequence of materials is a layer of sand and silt which has been deposited in the valleys since the arrival of European man in the area. (Figure 17) This unit has been named the Post-Settlement Alluvium and varies from 1 to 12 feet in thickness. As mentioned previously, when this area was settled, vast amounts of forest land were cleared for agriculture. This layer is the depositional equivalent of the erosion in the head lands.

This layer is unconsolidated and has very little strength of its own. When underlying layers are eroded from under this material, it will spall off and form vertical banks. When high river stages encounter this layer, large scour pockets and gullies develop.

Fig. 17. Post-Settlement Alluvium in Bank

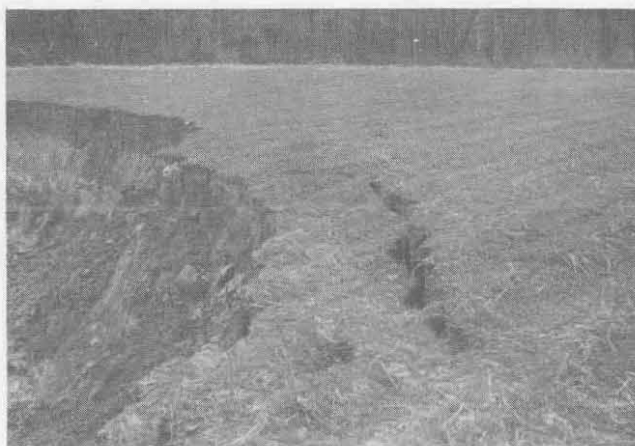
The bank erosion process is instigated by a headcut moving upstream. During this process, the banks, which were previously stable, are undercut. Tension cracks (Figure 18) soon develop in the soil on the top bank along zones of weakness in the soil structure. These cracks usually form from 1 to 6 feet away from the top bank line. When the soil on the streamward side of the tension crack becomes saturated or when the cracks enlarge and deepen to a significant extent, the blocks of soil topple into the stream. (Figure 19) These blocks are then eroded away and the stream again attacks the toe of the bank. As more degradation moves through a stream, the banks become more susceptible to this process due to the increased vertical height of the banks.

Fig. 18. Tension Crack in Top Bank

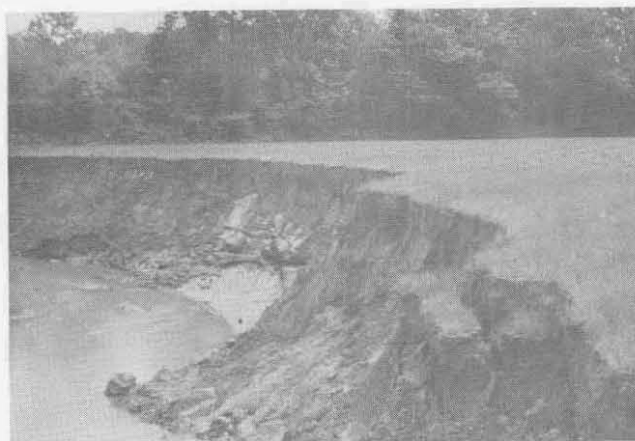
Fig. 19. Blocks About to Topple

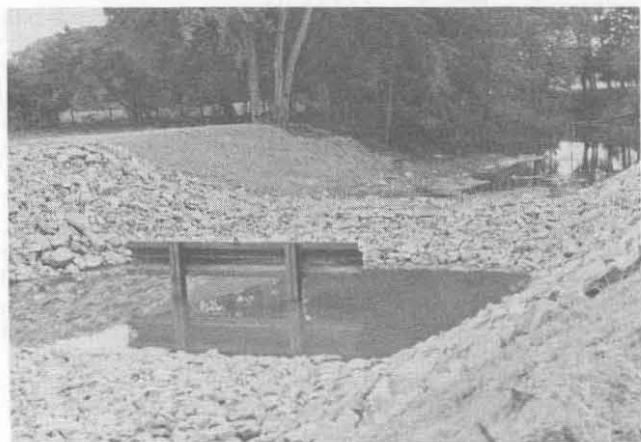
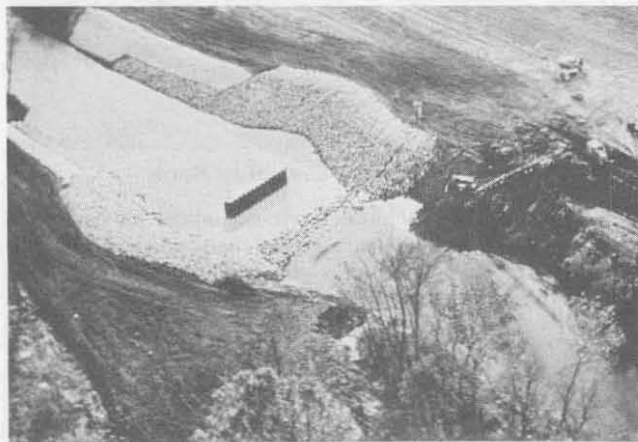
Fig. 20. Grade Control Structure - Perry Creek

Fig. 21. Grade Control Structure - North Fork Tillatoba

One of the main objectives in the Vicksburg District's Section 32 program is the construction of grade control structures on several Yazoo Hill Streams. (Figures 20-21) These structures consist of a sheet pile water cut-off weir, a pre-formed scour hole which is lined with rip-rap, and a hydraulic energy dissipating baffle. These structures are successfully creating a man-made bed control of these streams and stopping headcuts from moving
