**YAZOO BASIN - STREAMBANK EROSION CONTROL
EVALUATION AND DEMONSTRATION PROJECT**

Roy O. Smith

Chief, Hydraulics Branch
Vicksburg District
U. S. Army Corps of Engineers
Vicksburg, Mississippi

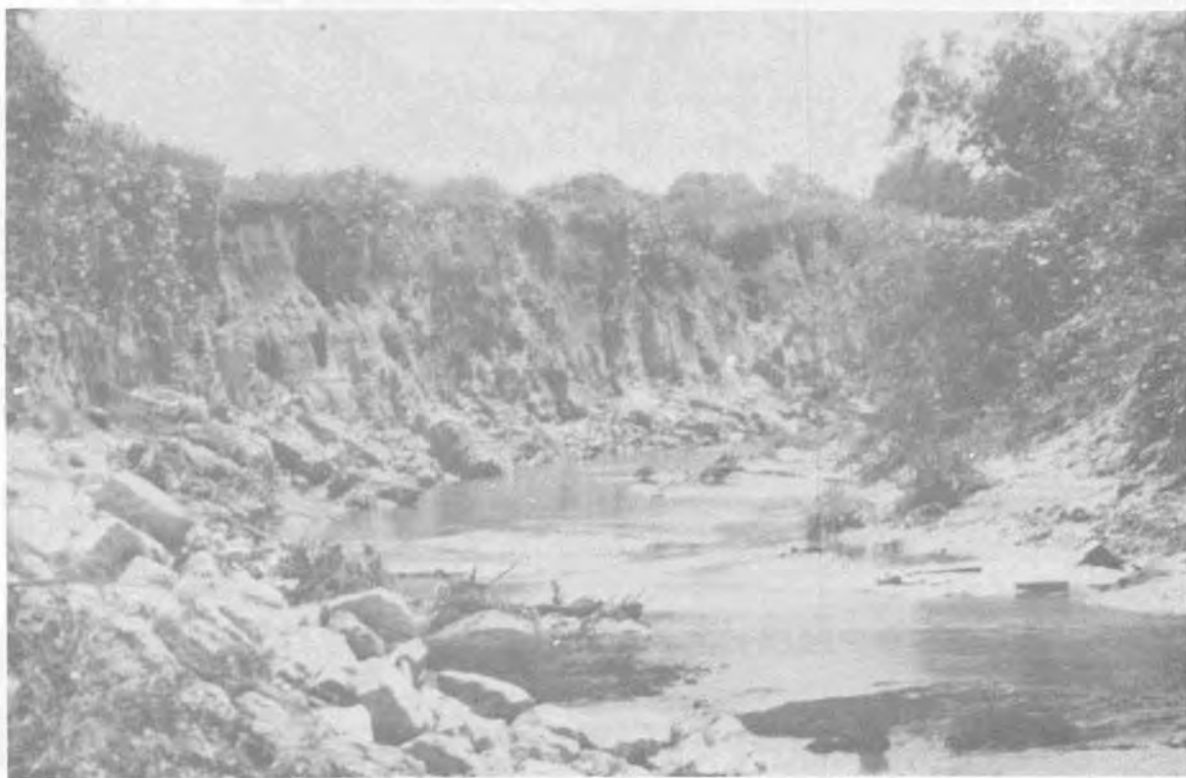
Most of the small tributary streams in the Yazoo Basin probably looked like the stream in Figure 2 prior to settlement of the area. There were defined channels, vegetated to the top bank with a tree canopy overlapping the stream. Now, many of the streams have eroded badly, entrenched themselves deep into the highly erodible soils, and are choked with debris and sand (Fig. 3). Many factors have

Figure 3. Heavily Eroded Stream

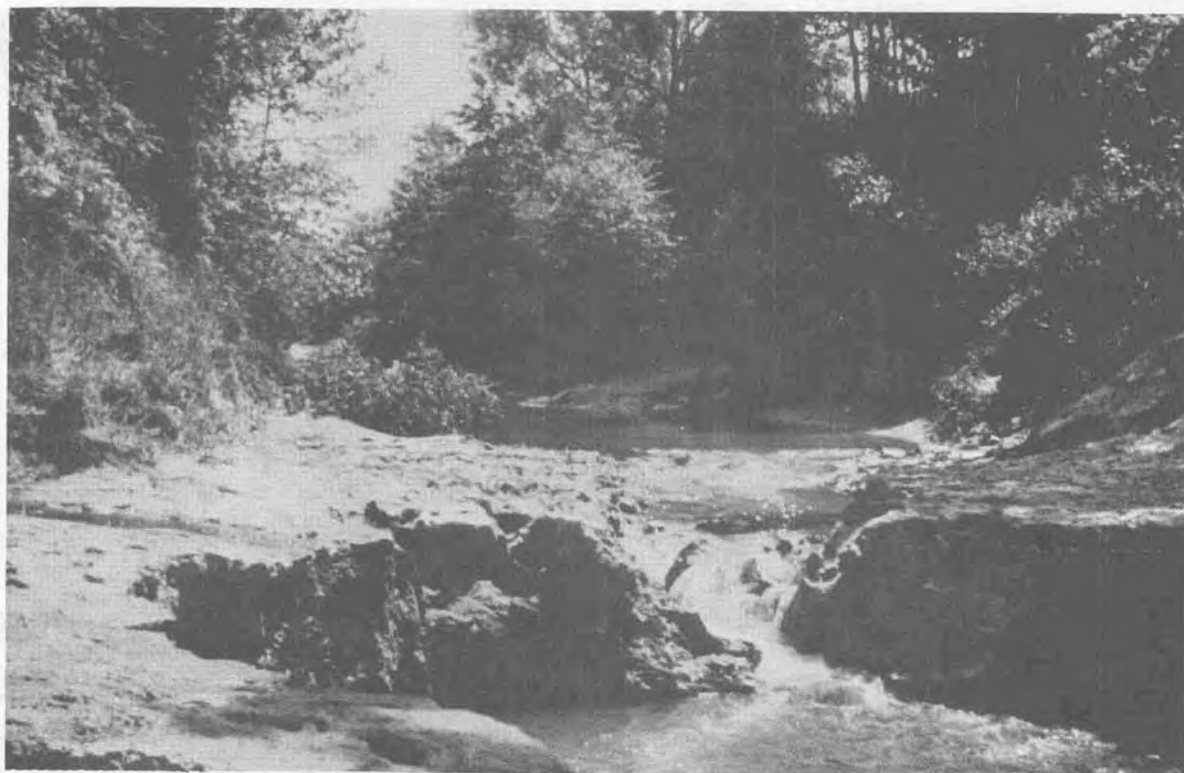
You may have noted earlier that I referred to the problem as a streambed and bank erosion problem. We believe that a majority of the serious bank caving problems within the hill area of the Yazoo River Basin are attributable to bed instabilities. For instance, if the degradation trend begins on a stream because of one of the factors mentioned earlier, the bed will degrade and the banks will then fail. (See Figs. 4 & 5). Because of this, we have divided the program into three major areas of activity:

Our second approach to the problem involves grade control. The idea here is to install a "hard point" in the streambed to prevent degradation from progressing upstream. Figure 22 illustrates a typical head cut in Perry Creek. Figure 23 is a typical grade control structure used to control head cuts. By controlling the head cut, bed degradation is controlled, preventing future bank caving upstream of the degradation. Figures 4 & 5 show the difference in character of the stream above and below a head cut.

Figure 4. Headcut Viewed Upstream

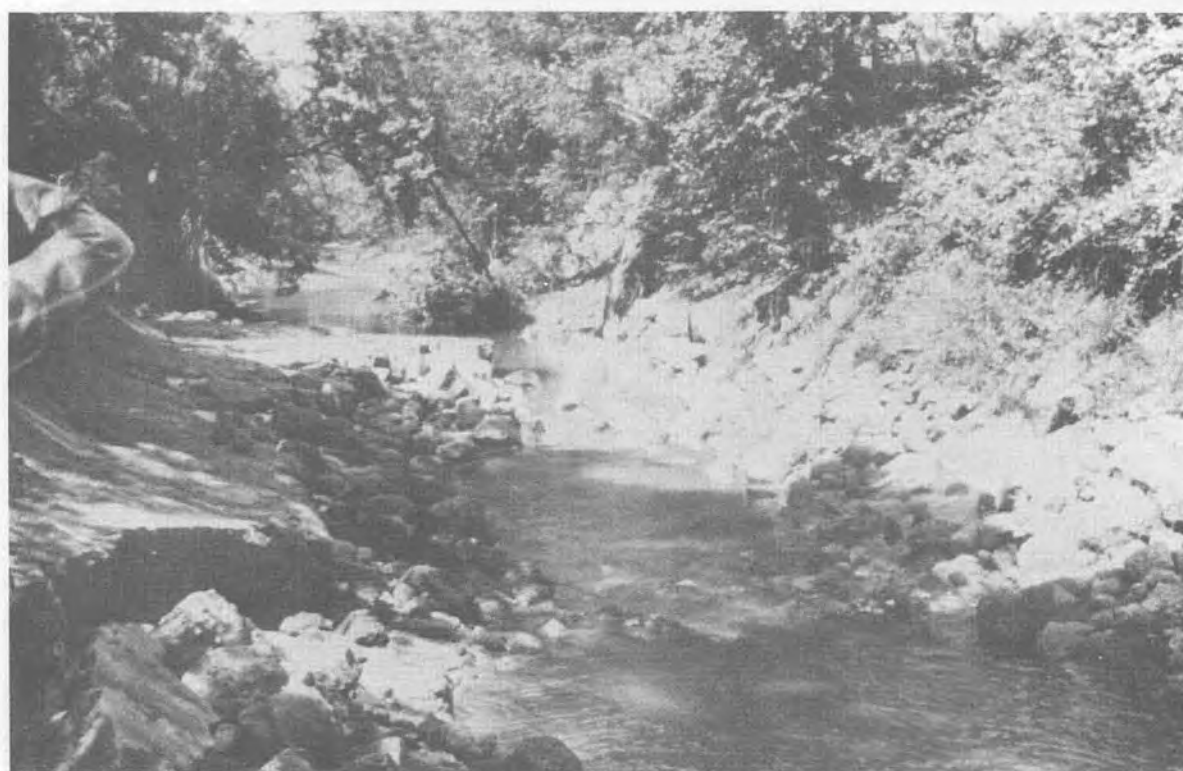
Figure 5. Looking Downstream of Headcut

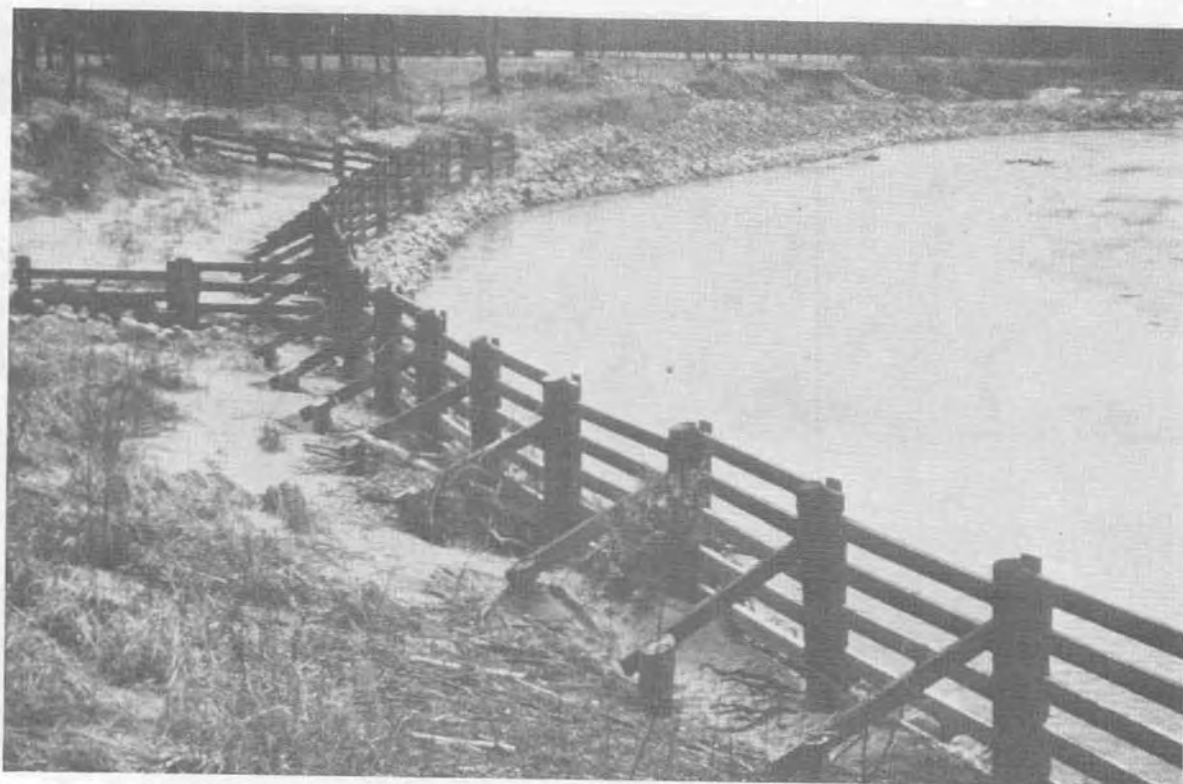
Figure 6. Board Fence Revetment

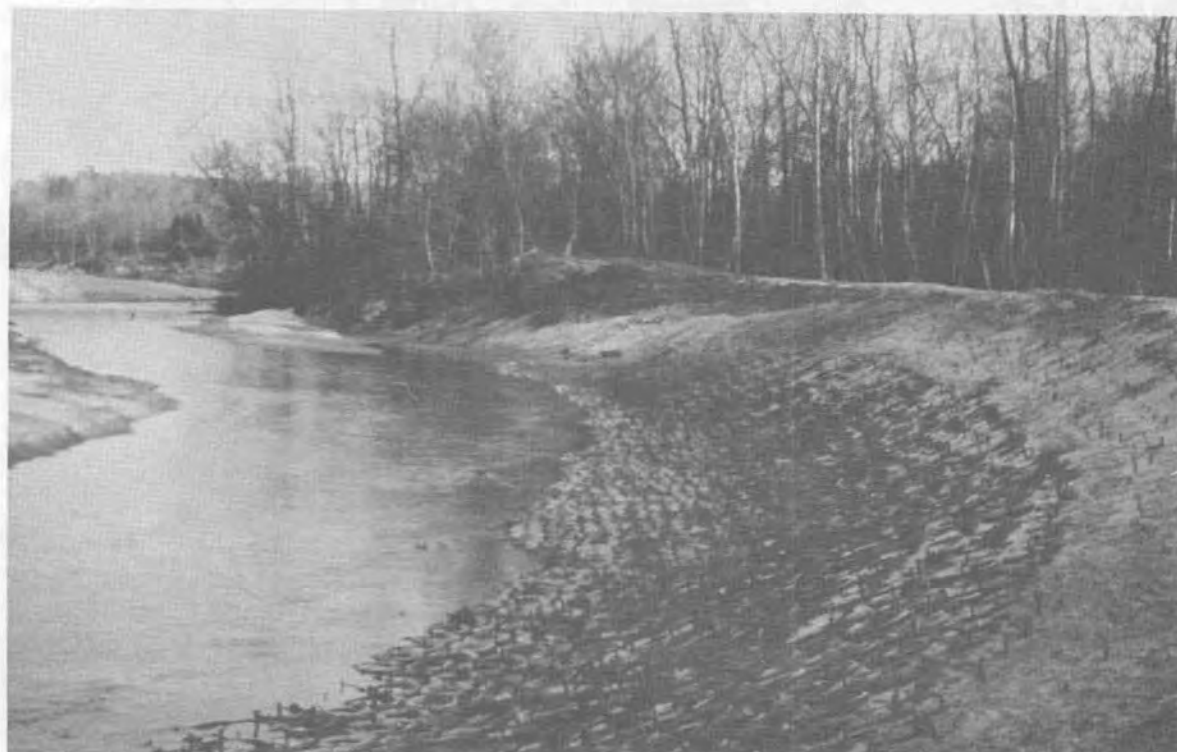
Figure 7. Used Tire Revetment with Willow Stob

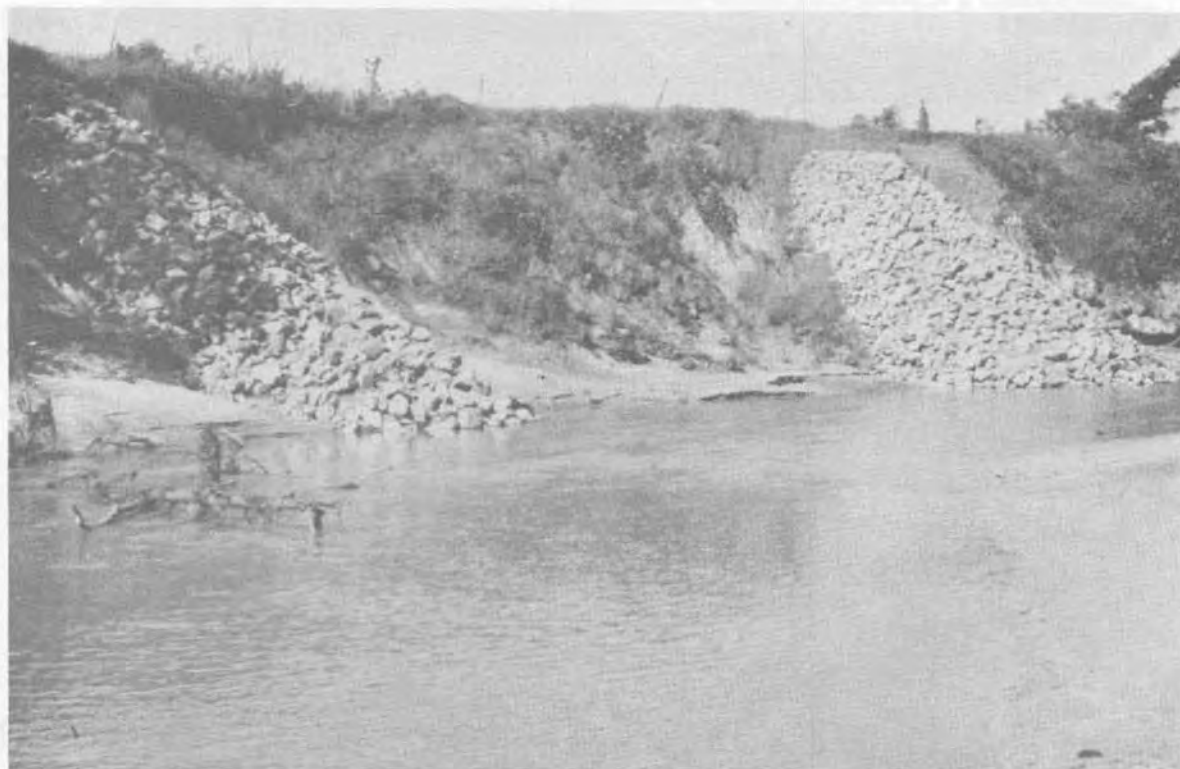
Figure 8. Transverse Stone Dike

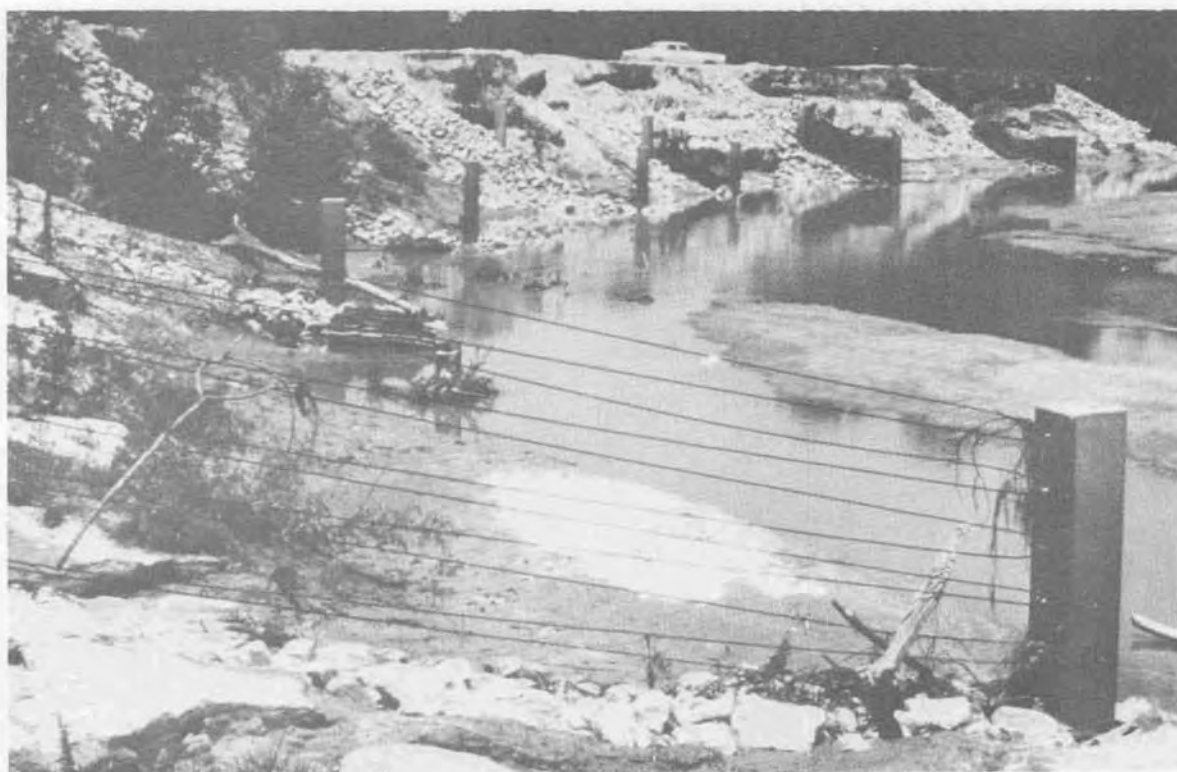
Figure 9. Wire Post Retards

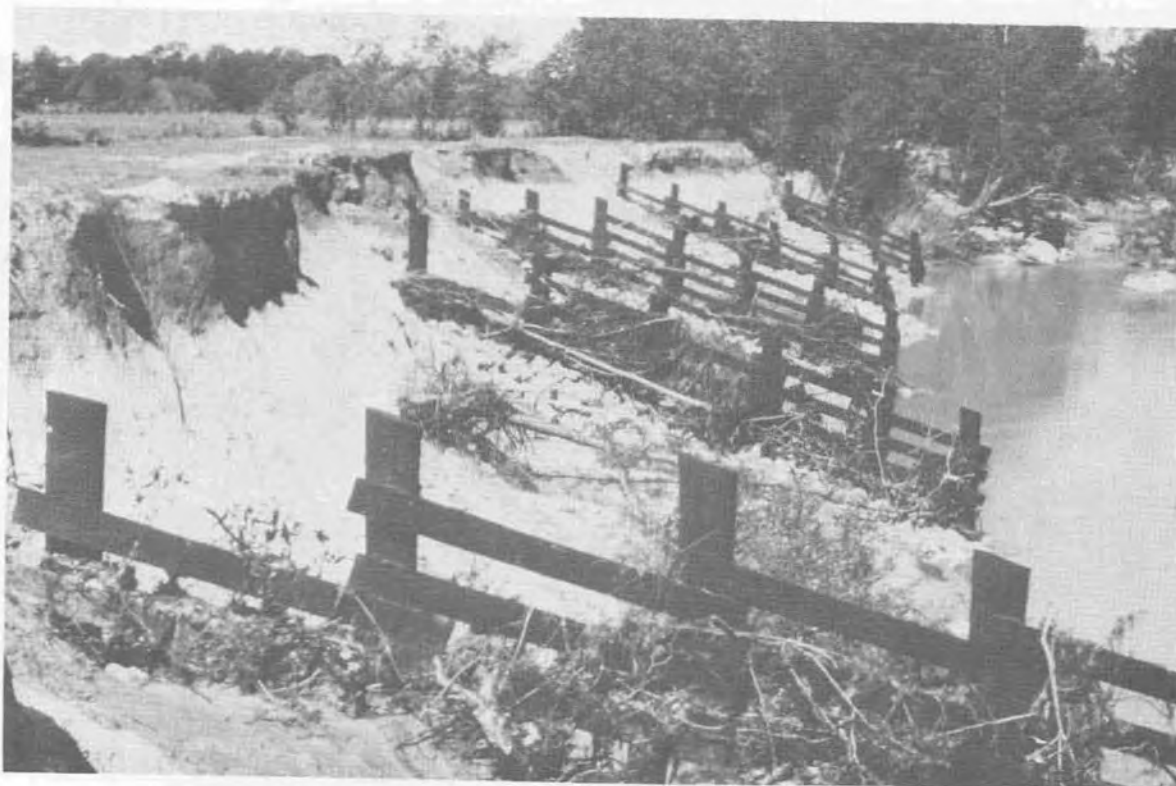
Figure 10. Board Fence Retards

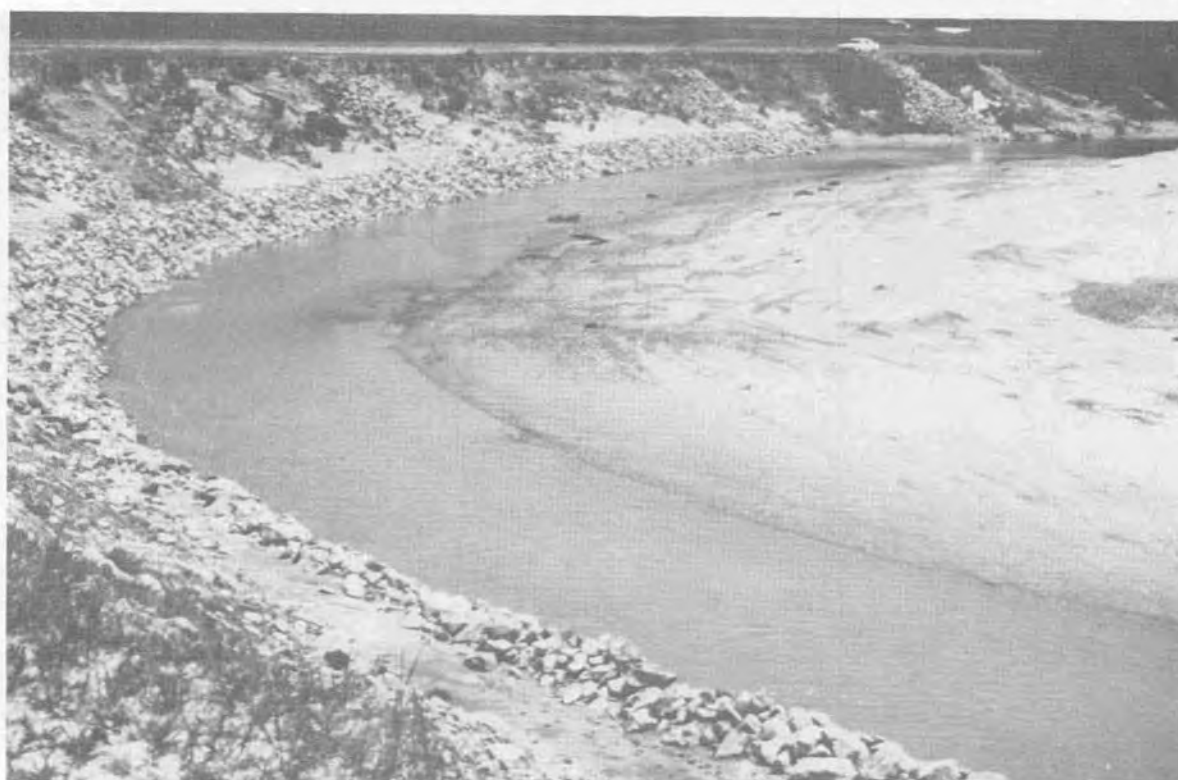
Figure 11. Longitudinal Stone Dike with Tie Back

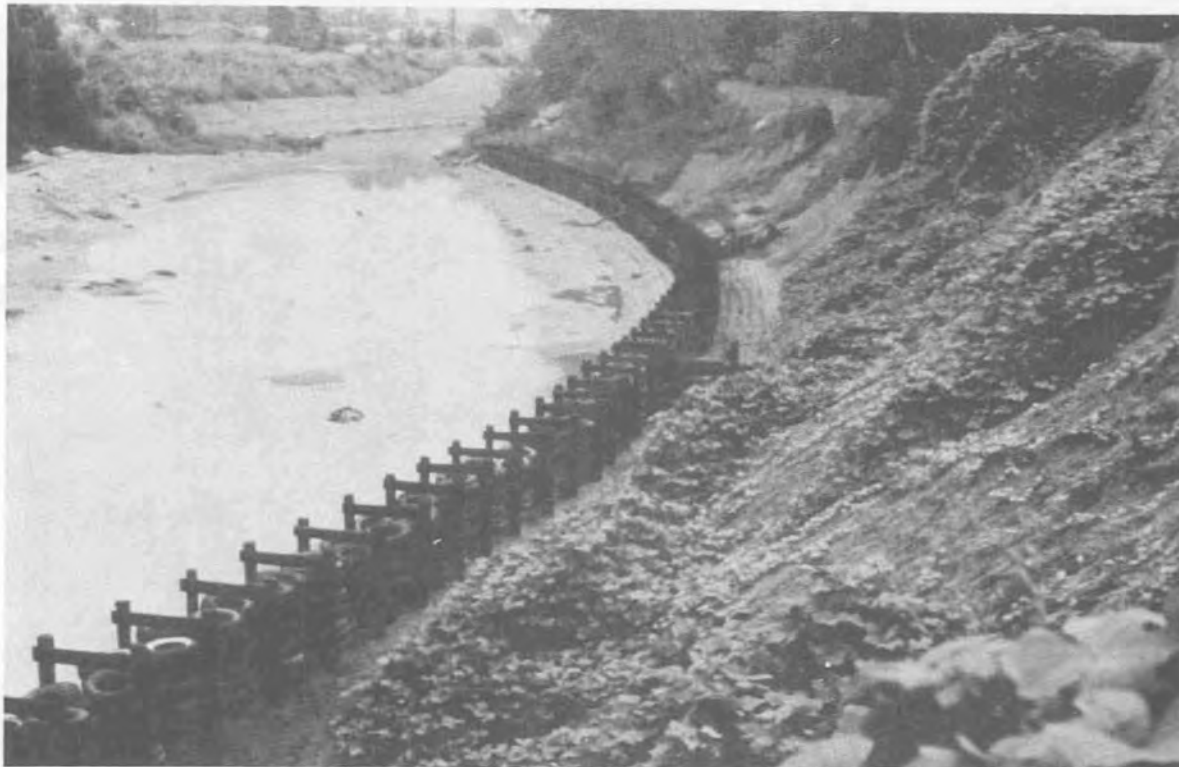
Figure 12. Longitudinal Toe Protection Using Used Tires

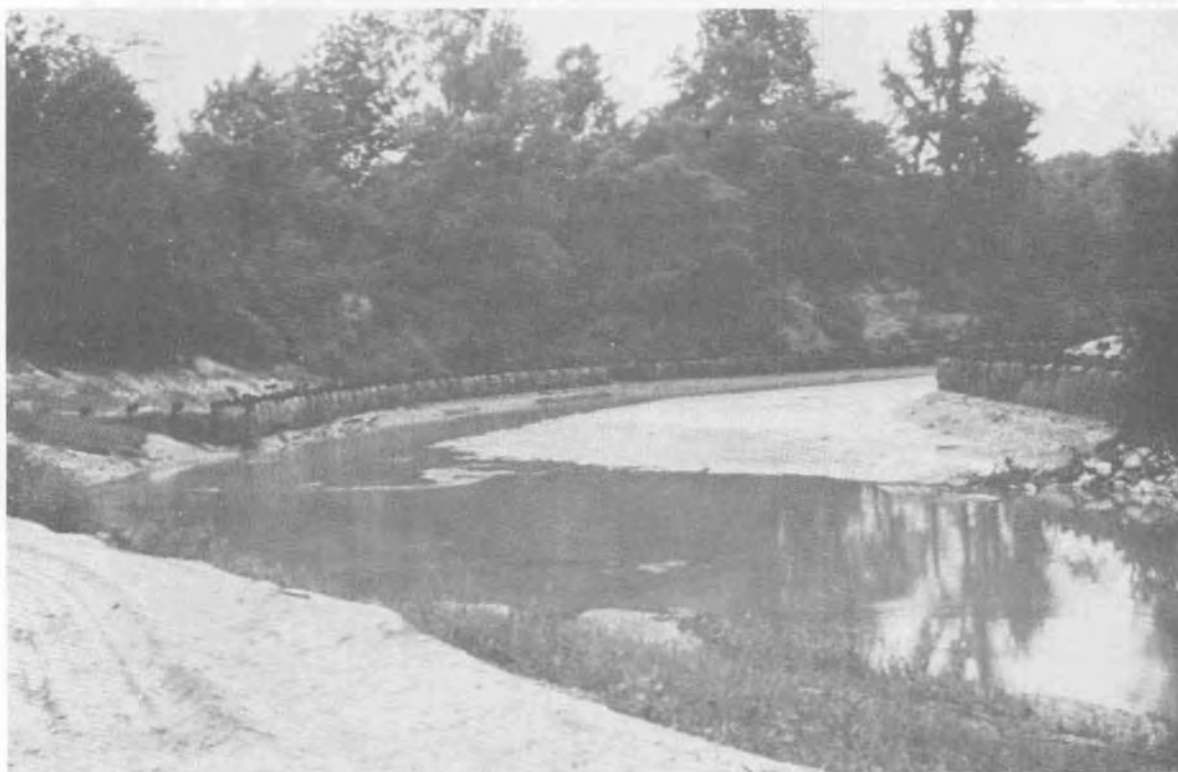
Figure 13. Longitudinal Toe Protection Using Hay

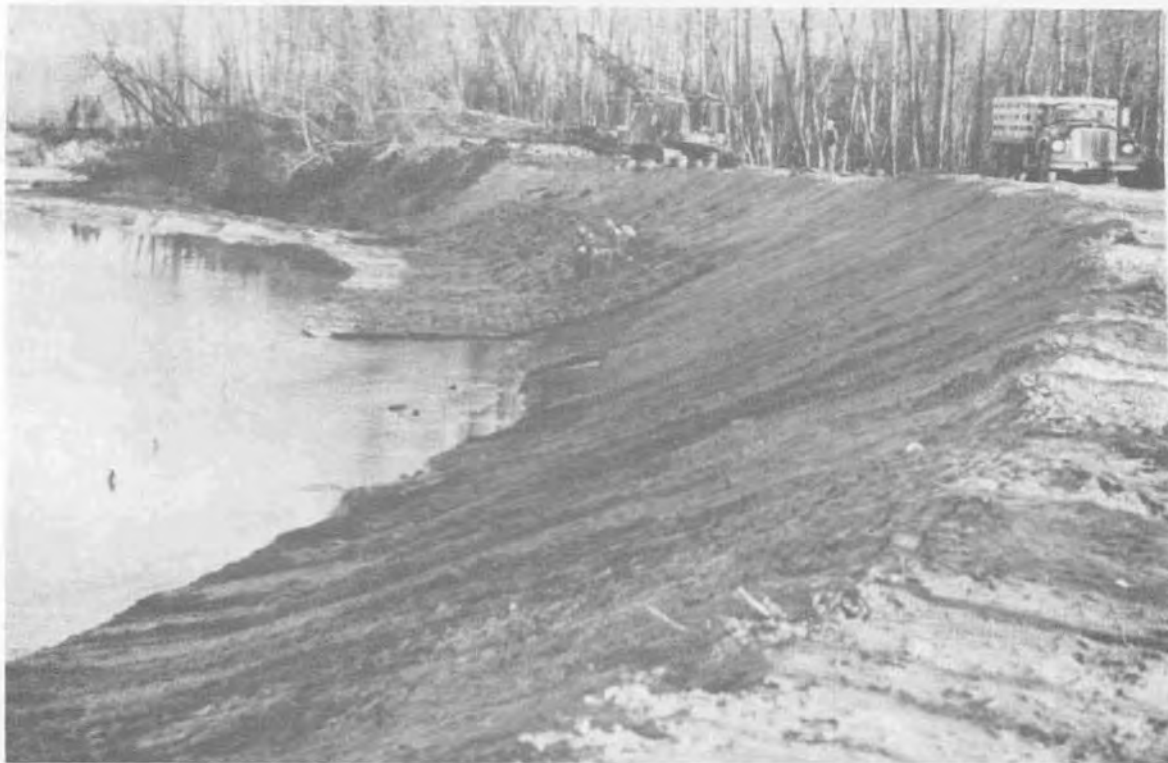
Figure 14. Placing Used Tire Revetment with Willow Stobs

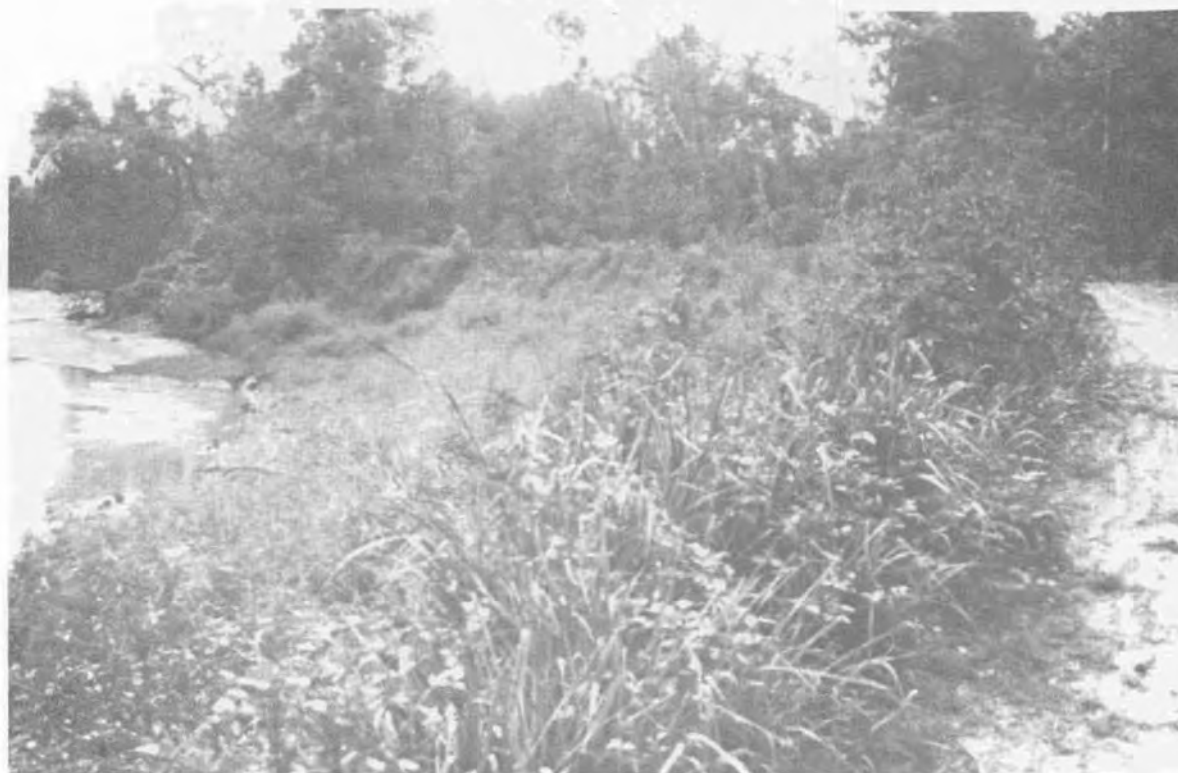
Figure 15. 1 Year Later Note Willow Growth

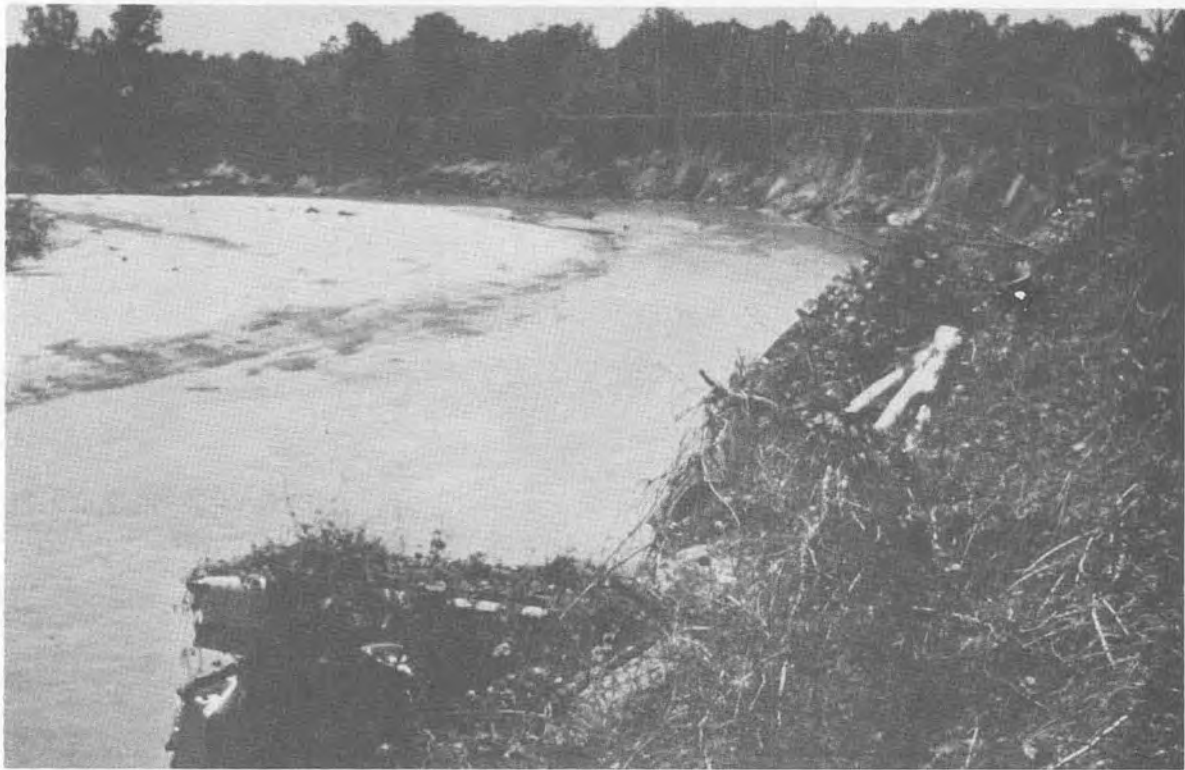
Figure 16. Before Bank Protection

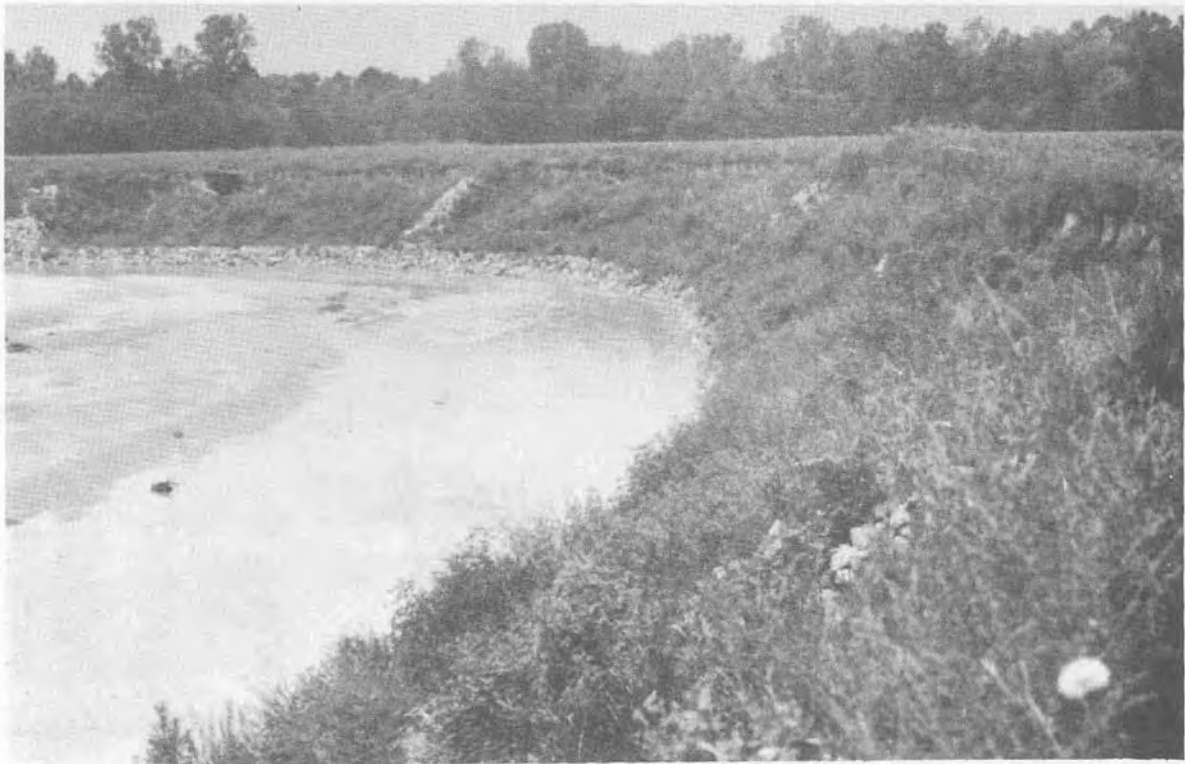
Figure 17. 2 Years After Longitudinal Stone Dike with Tie Back

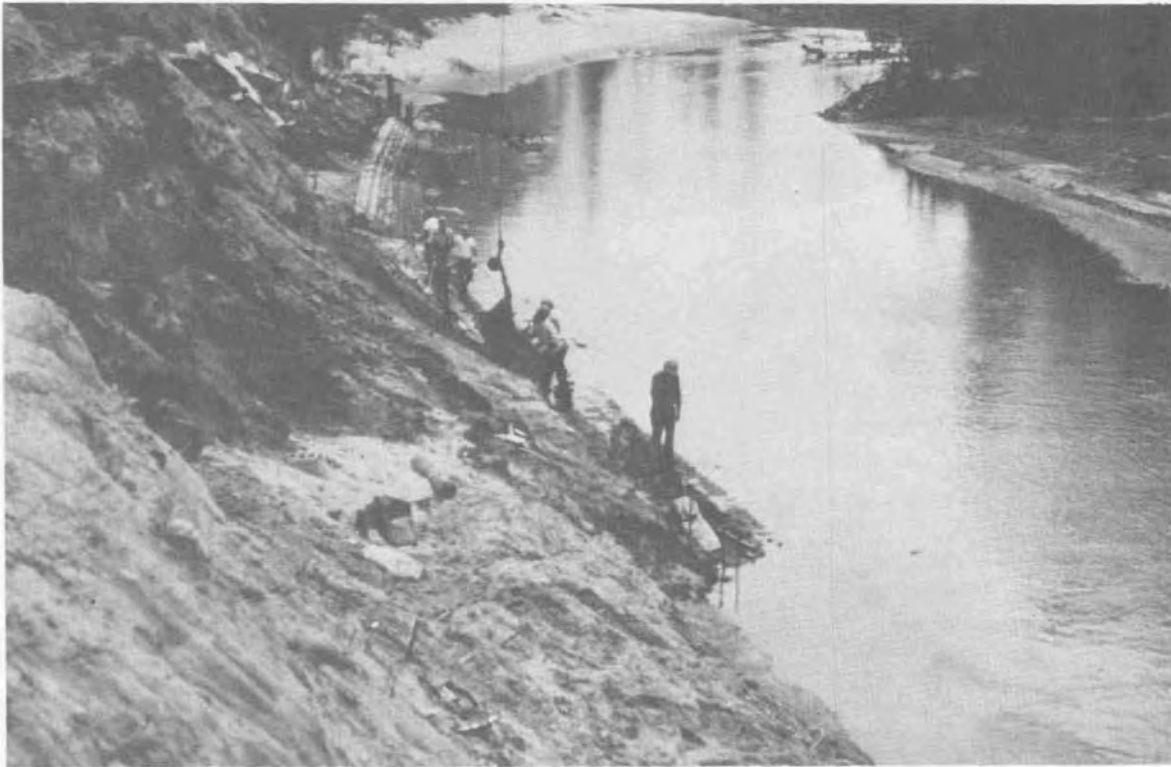
Figure 18. Placing Soil Cement Sack Revetment

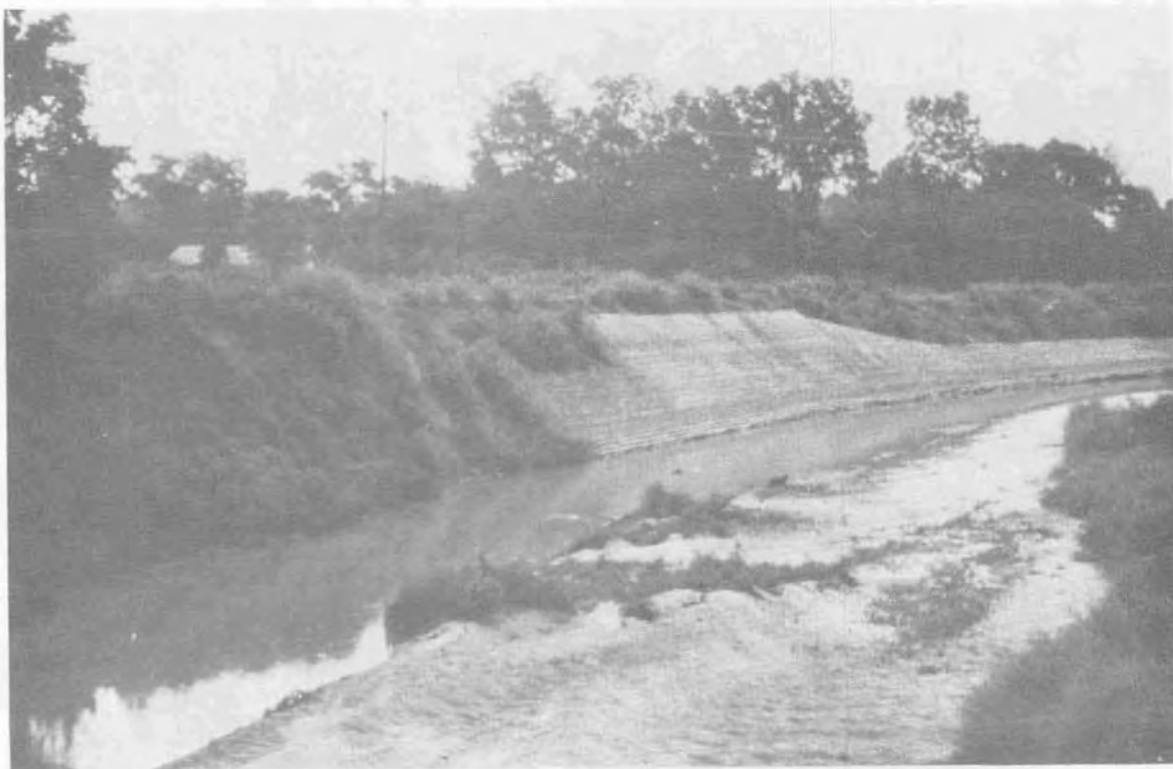
Figure 19. Soil Cement Sack Revetment in Place

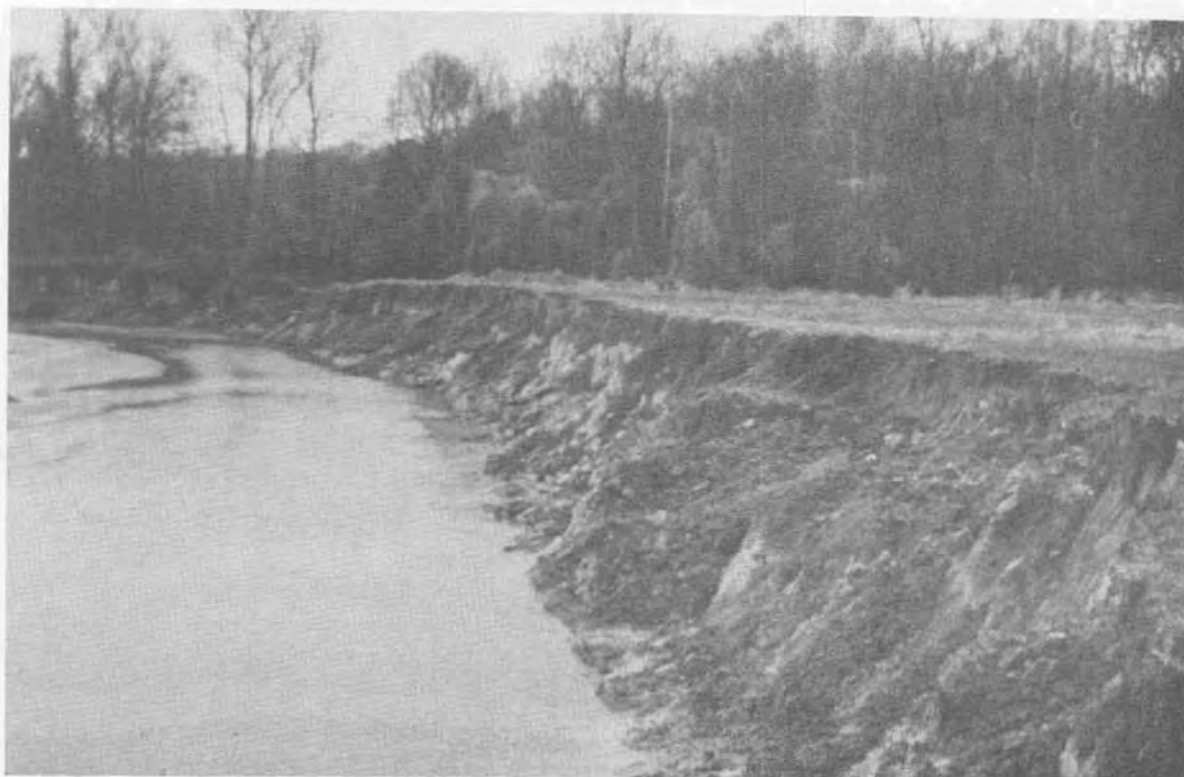
Figure 20. Before Bank Protection

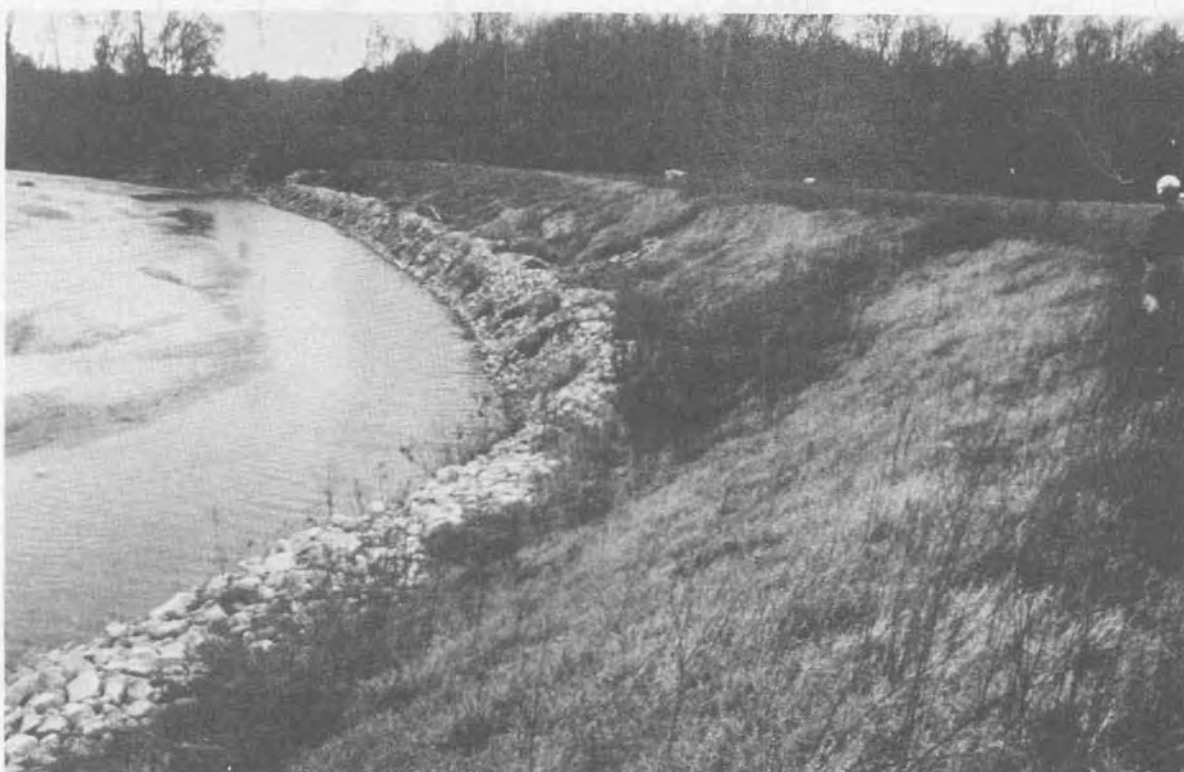
Figure 21. Longitudinal Stone Dike with Upper Bank Seeding

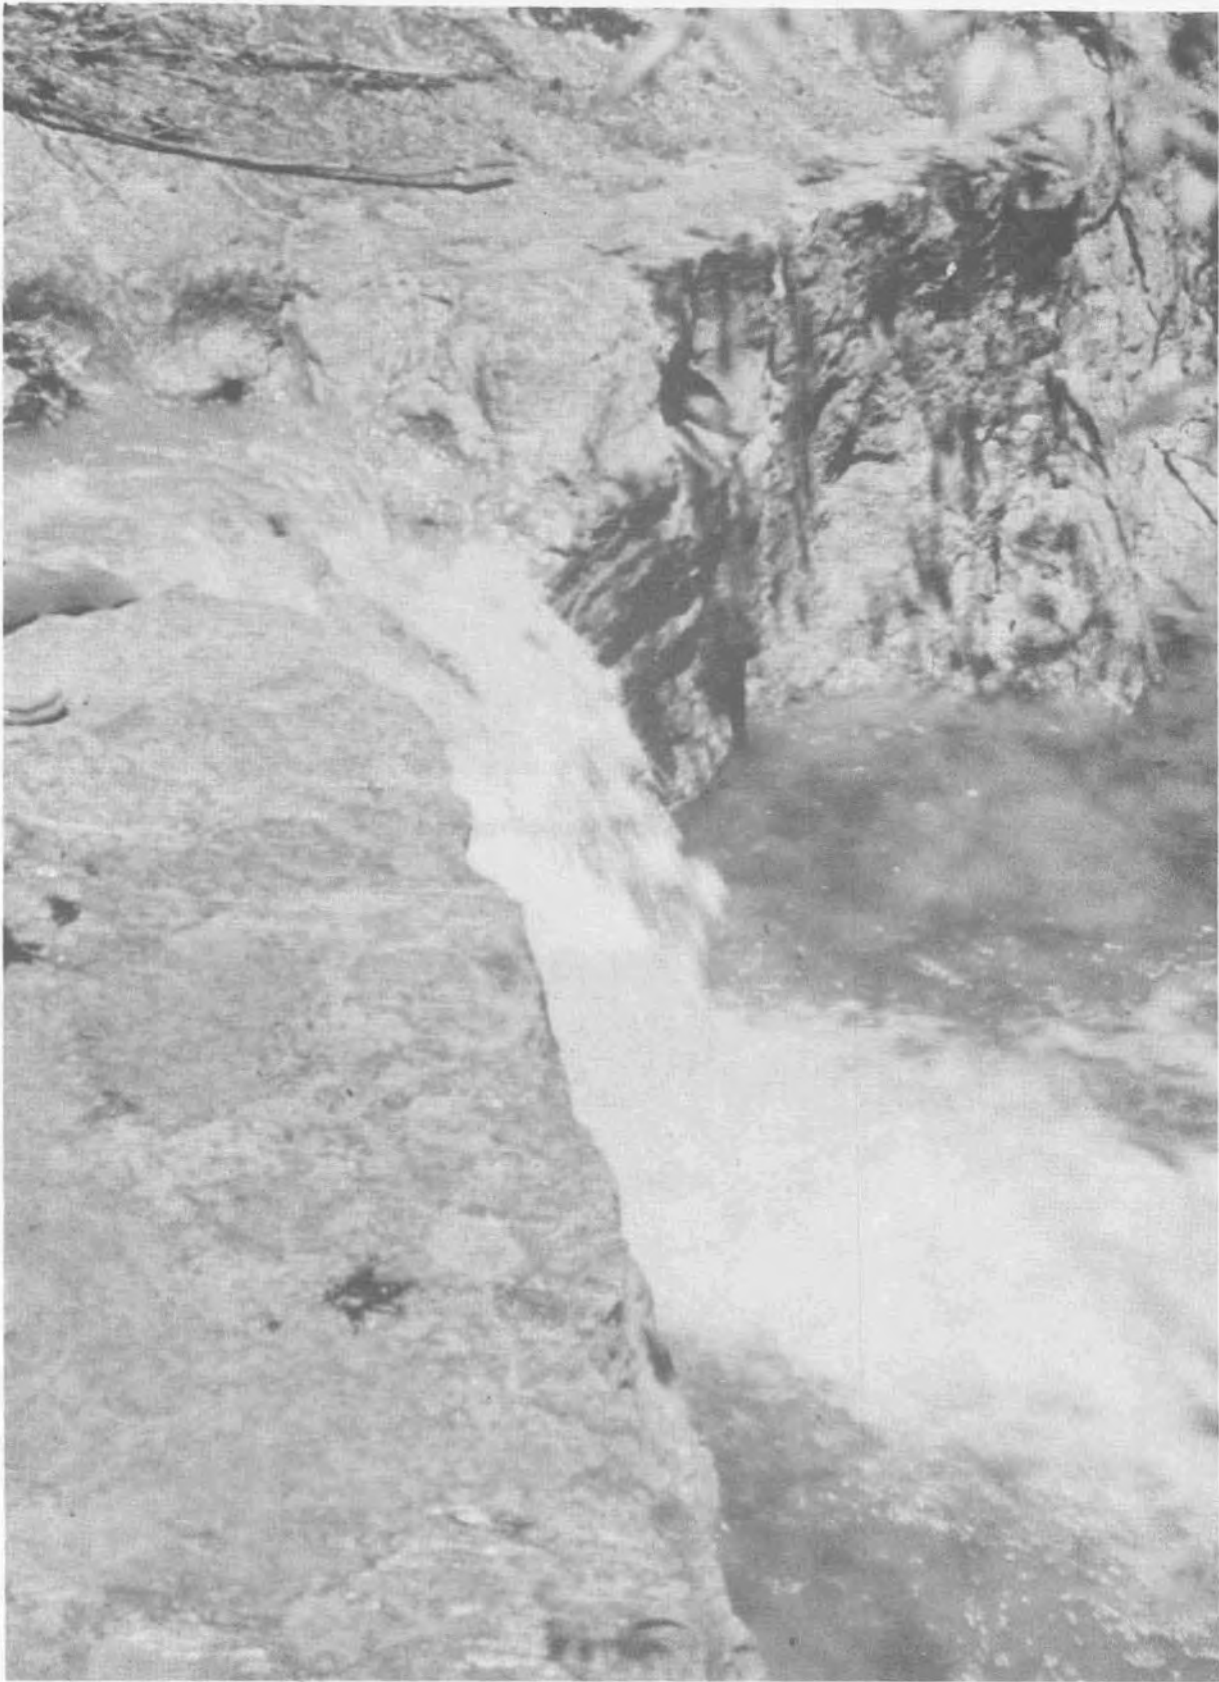
Figure 22. Head Cut on Perry Creek

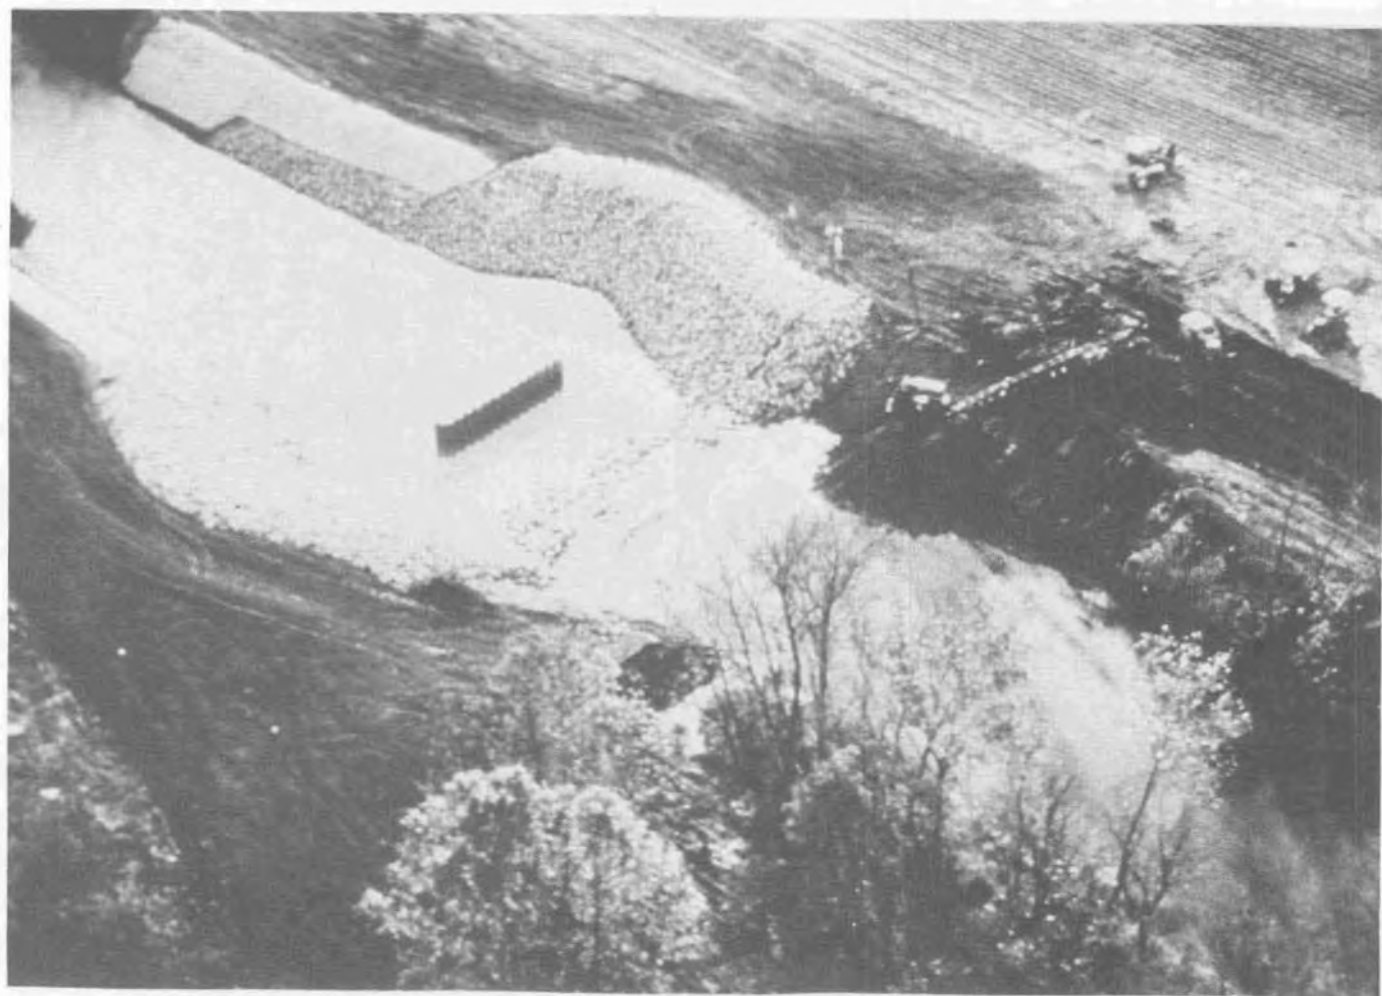
Figure 23. Grade Control Structure
