STORM DRAIN REPLACEMENT USING A SALT MARSH IN BILOXI, MISSISSIPPI

*P.O. Melby, **T.P. Cathcart, ***C. Moncreiff, and ***J.D. Caldwell

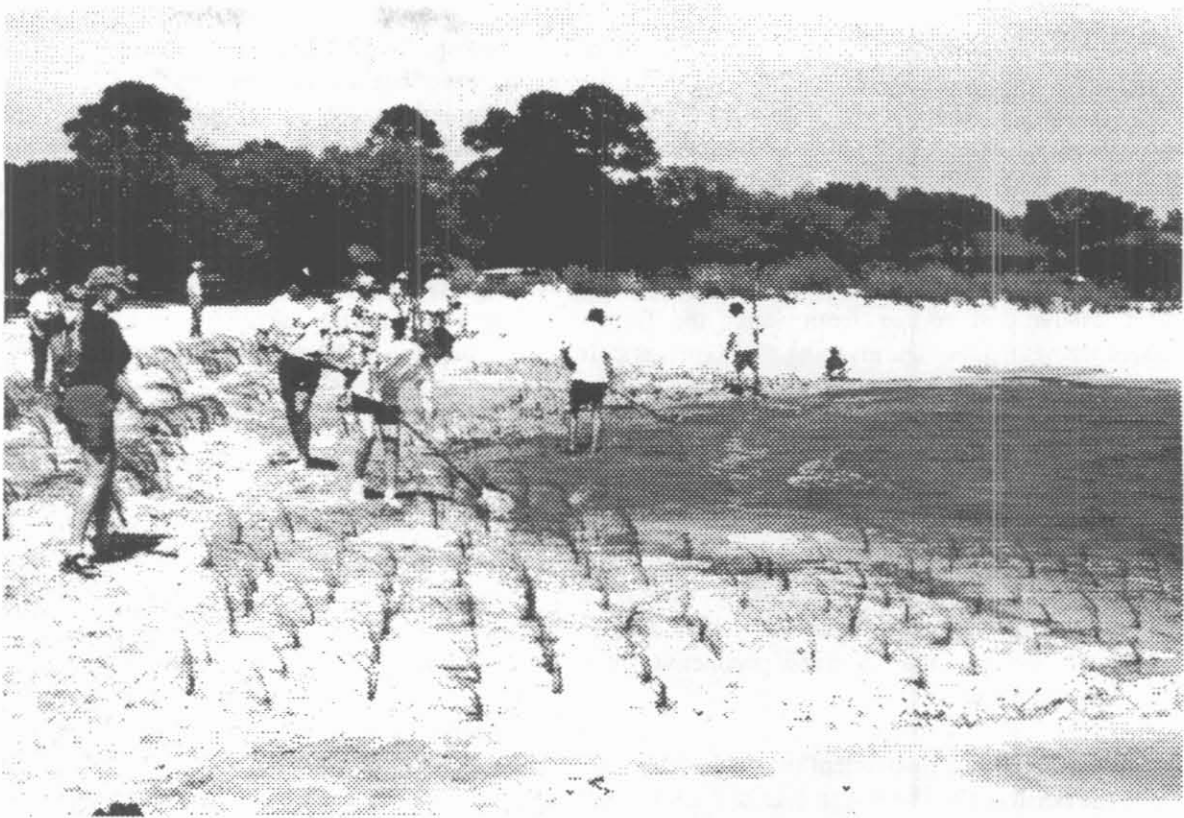
Figure 3. Marsh construction, Spring, 1995.

The marsh planting was conducted by students from Mississippi State University, a local high school, representatives of the Chamber of Commerce, and the authors (Figure 3). Low marsh plants, primarily *Spartina alterniflora*, were placed at the lowest elevation. Upper marsh plants, primarily *S. Patens*,

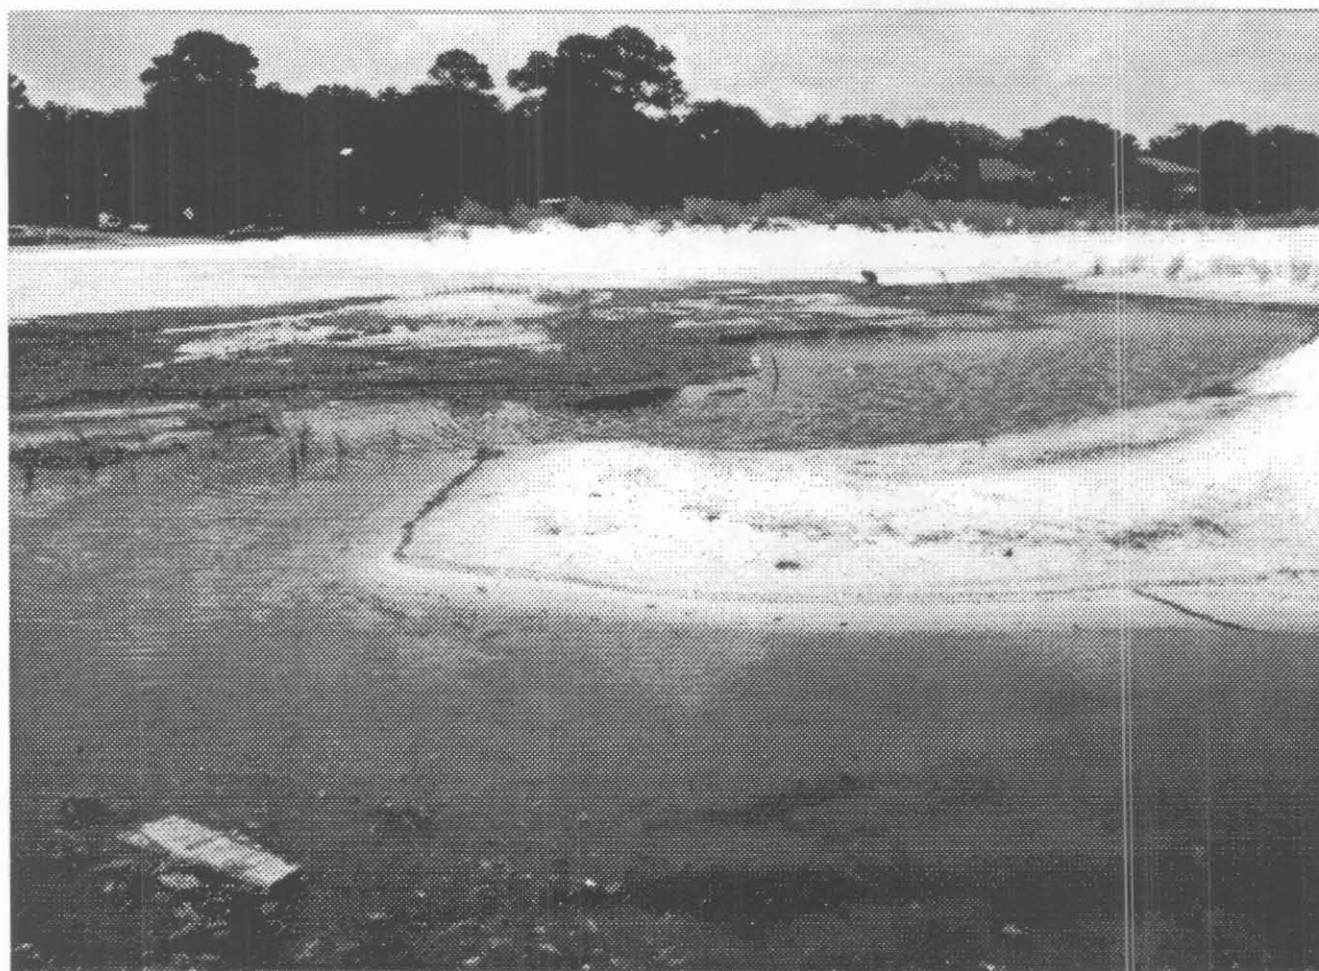
Figure 5. The constructed salt marsh after several months exposure to weather and tides.

During the first year, there has been substantial progress toward the development of a naturally functioning salt marsh (Figure 5). The planted vegetation withstood several severe storm tides, took root, and began the natural process of accumulating detritus. The accumulated detritus provides mineral nutrients and organic matter and retains fresh water for further community development. The invading plant species thus far have primarily consisted of annuals that naturally invade bare littoral habitats. Even at the earliest stages, the habitat diversity provided by the planted vegetation was attractive to birds. As the process of succession continues, the new salt marsh will grow in significance as a natural filter for materials flowing into the Mississippi Sound and as habitat for an increasing variety of vertebrate and invertebrate organisms. With further development, the site may become productive as a nursery for aquatic animals.
