Conservation Planning integrating site assessment and hydrologic modeling at the Mississippi State University Dairy Unit, Sessums, MS

Timothy J. Schauwecker, Jeremy Murdock, Kim Collins
Department of Landscape Architecture
Mississippi State University
PO Box 9725
Mississippi State, MS 39762
662-325-7895
Email: tschauwecker@lalc.msstate.edu

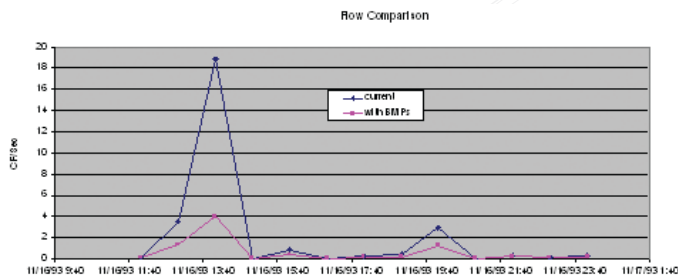
Figure 1. Model results for FLOW in Latis© (BASINS/HSPF)

The conservation practices modeled yielded a 72% reduction in flow as modeled in HSPF (Fig. 1).
